SECTION 32 PROGRAM
STREAMBANK EROSION CONTROL,
EVALUATION AND DEMONSTRATION
WORK UNIT 2-EVALUATION OF EXISTING
BANK PROTECTION

FIELD INSPECTION OF MORAMEAL REVETMENT
ON THE RED RIVER

Malcolm P. Keown, E. A. Dardeau, Jr.

September 1979
Inspection Report 7

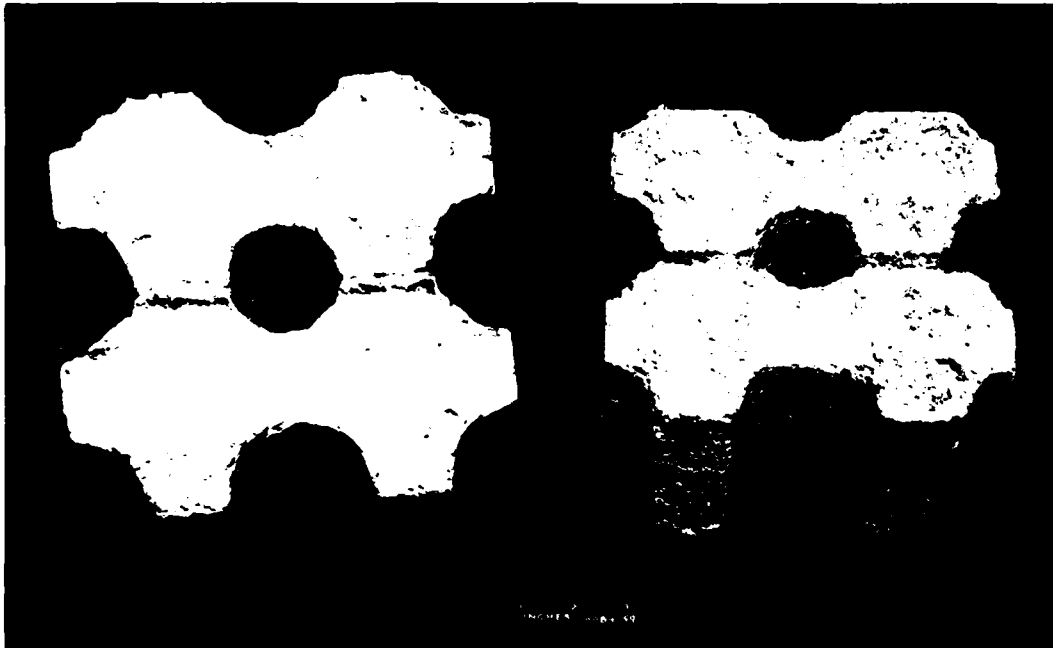
9. Gobi Blocks, manufactured by Erco Systems, Inc., New Orleans, Louisiana, were used as upper bank paving for Section B (sta 10+00 to 25+00). The Gobi Blocks are cellular concrete blocks cast using sand, gravel, 20 percent cement, and water. The mix is pressed into molds to form blocks (Figure 8). The blocks used under this contract were 8-in. square and 4 in. thick, weighing approximately 12.5 lb, with 232 blocks being required to cover a square (i.e. 100 sq ft). Four unskilled laborers placed an average of 6,000 to 7,000 blocks in a 10-hr day. Placement of the blocks was often difficult because of the variation in surface topography and the heavy rains that persisted during the installation. During the placement effort, there was some sliding of the blocks on the saturated bank. Figure 9 is a downstream view of Section B. A detailed view of the Gobi Block installation is provided in Figure 10; note that vegetation has begun to grow in the open areas within and between the blocks. This revetment section has never been subject to attack by high-velocity flow or wave action. Several small depressions were noted during the inspection visit (Figure 11), where the blocks have settled as a result of leaching of underlying bank

Figure 8. Gobi Blocks
